# KENT STATE UNIVERSITY

## CAPITAL NEEDS ASSESSMENT REPORT

October 30, 2025

**Re: Capital Needs Assessment of Kent State Stark Conference Center**

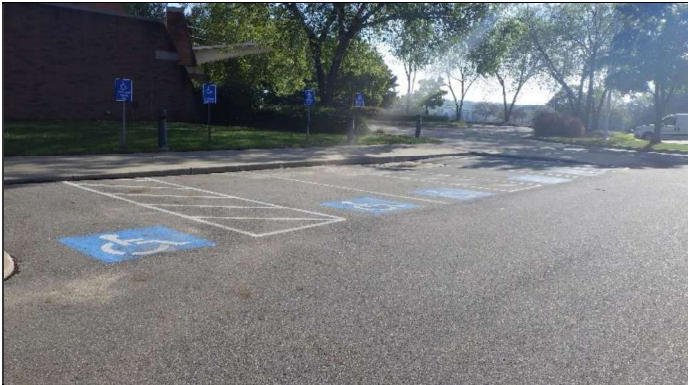
Vehicular access to the property is provided from the south adjacent to the property. The vehicular entrance and parking areas are asphalt paved surfaces. The paved asphalt was in overall fair condition. A few sporadic pavement cracks were noted across the parking area. According to historic aerial imagery, the asphalt pavement was last seal coated and striped in 2023.

Asphalt pavement crack

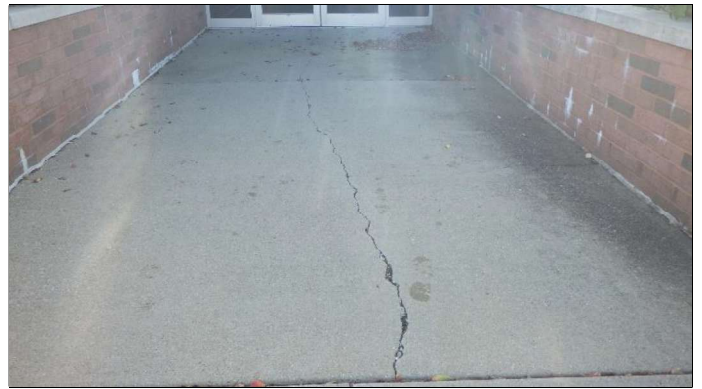
The property contains a concrete walkway that is located around the perimeter of the building and connects the parking area to building entrances at each elevation. Sporadic cracks were in a few concrete slabs to the walkway. Some sections of concrete appear to have settled causing an elevation difference in the walkway greater than one-quarter of an inch making it a potential tripping hazard.

Concrete sidewalk crack

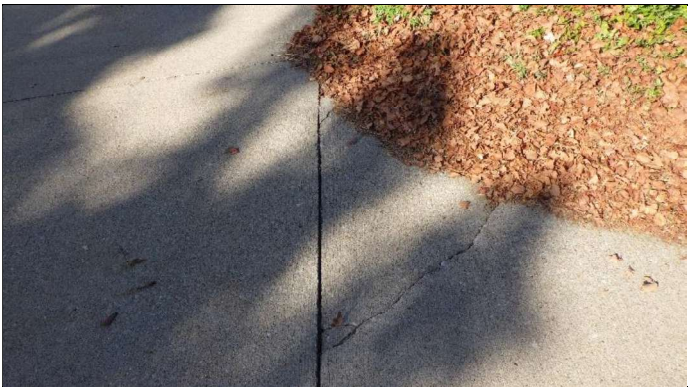
Concrete sidewalk crack

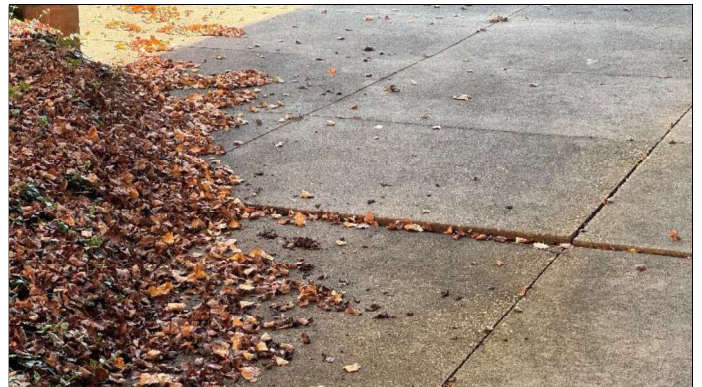
Potential tripping hazard in walkway

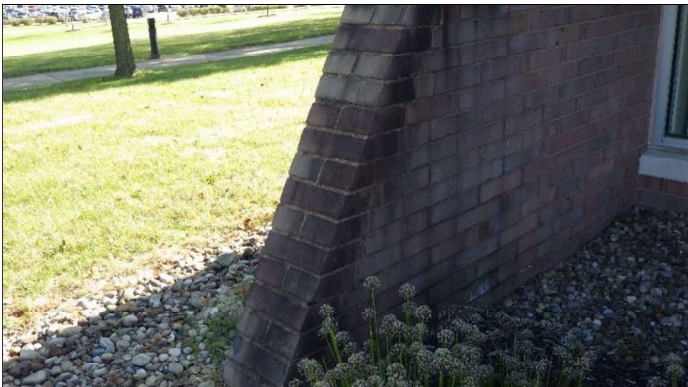
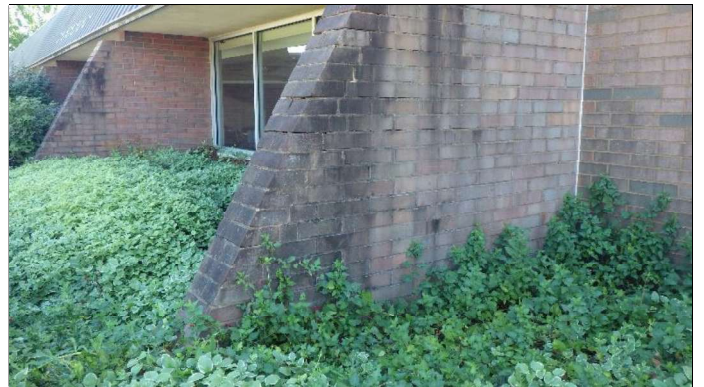
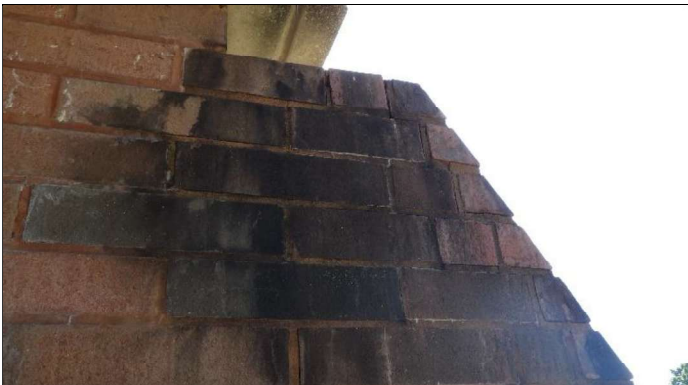
Stains, mortar cracks, efflorescence deposits, and deterioration of the brick veneer were identified at multiple locations, primarily to architectural buttresses throughout the exterior of the building. Efflorescence deposits are located primarily around weep holes within the brick veneer.

Typical stains on brick surface

Deterioration, spalling, and staining of the brick veneer were observed at multiple locations throughout the building. Repairing and refinishing the brick veneer will provide a fresh appearance to the building and help ensure the masonry stays watertight. The estimated cost to point and refinish the brick veneer is approximately \$9,400. The estimated cost to repair the brick veneer is approximately \$1,100.

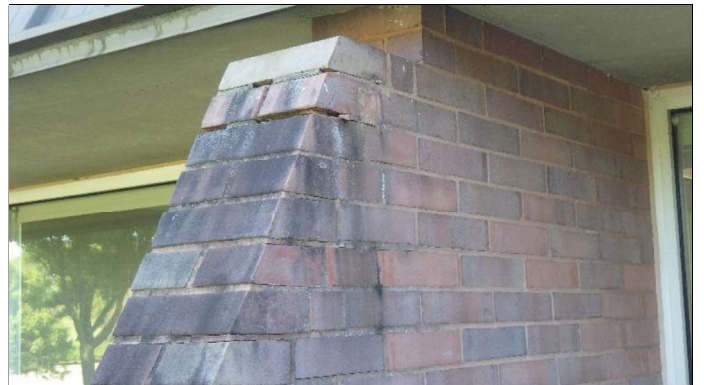
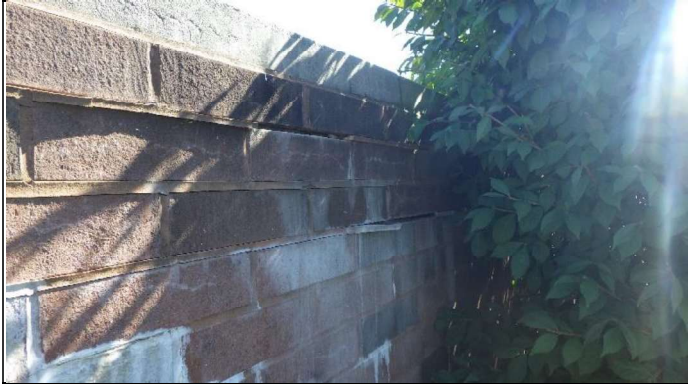
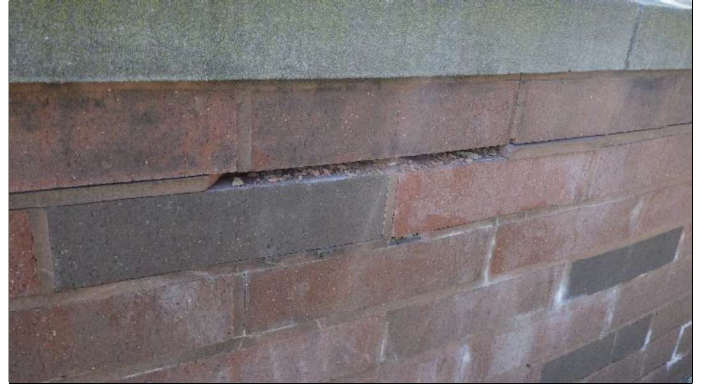
Typical mortar cracks

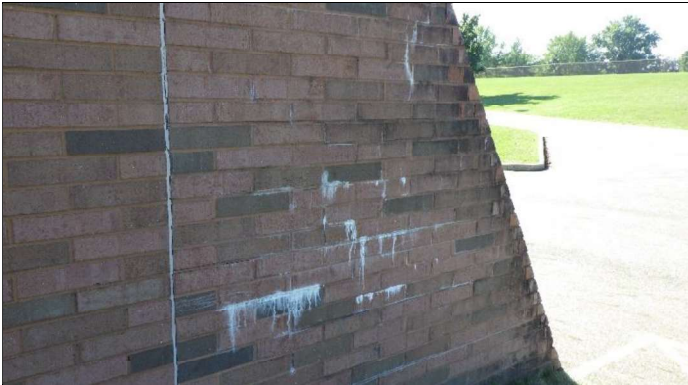
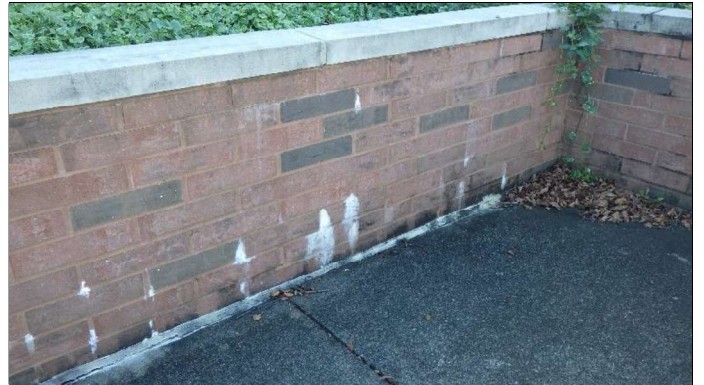
Typical efflorescence on brick surface

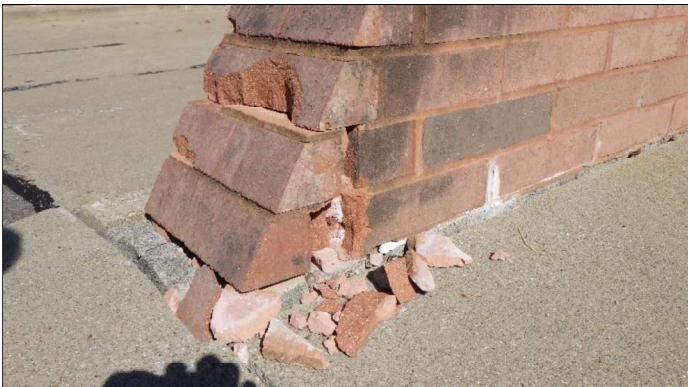
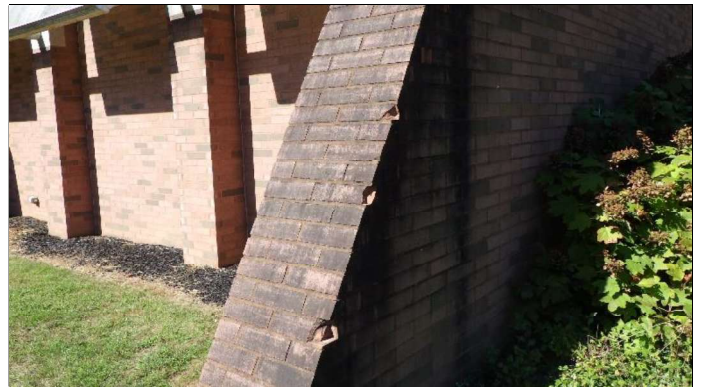
Cracks in the brick veneer

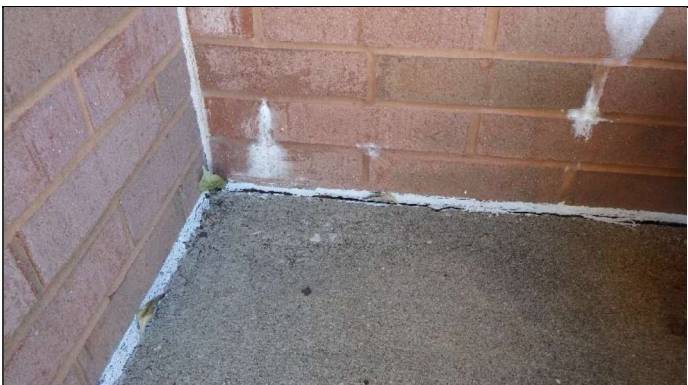
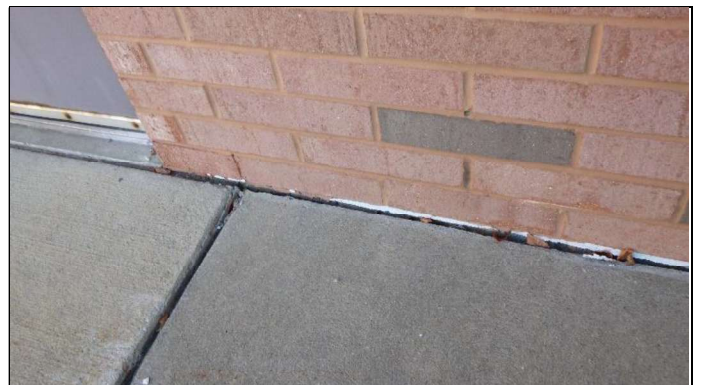
The sealant at the base of the brick veneer to the exterior wall finishes and/or knee wall exhibits deterioration throughout the property. The sealant within the vertical joints of the brick veneer to the building exhibits mild deterioration and is in fair condition.

Typical deteriorated base sealant to brick veneer

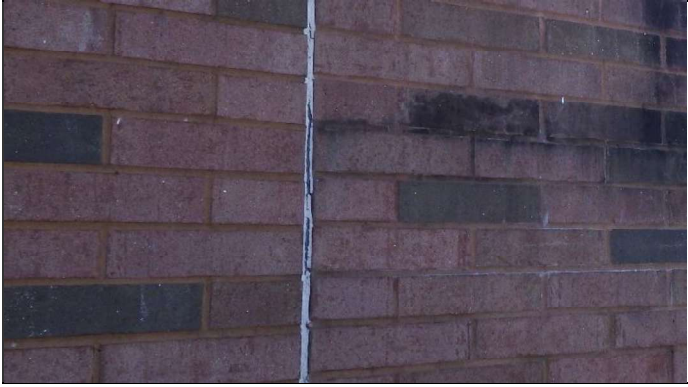
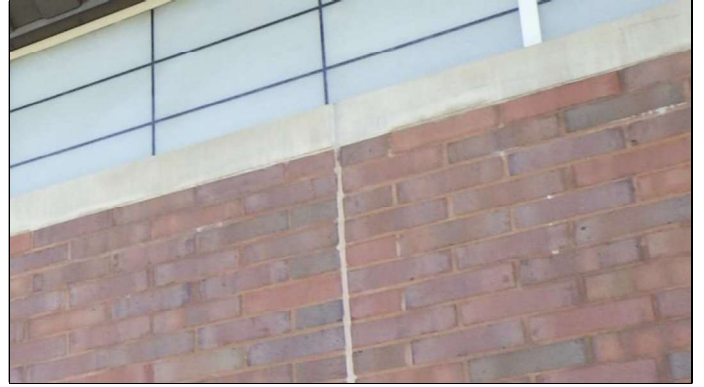
Typical deteriorated sealant in vertical joint

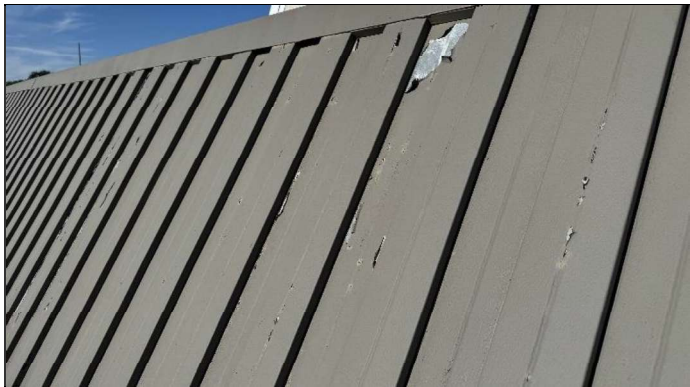
The roof also includes steeply sloped metal paneled sections on the exterior of the parapet walls. The coating on these metal panels is peeling at many locations, exposing the bare metal beneath. This condition is also occurring on the metal cap flashing along the south parapet wall of the lower roof. The caulking at the metal cap flashing joints is cracking in many locations.

Deteriorated finish on mansard roof

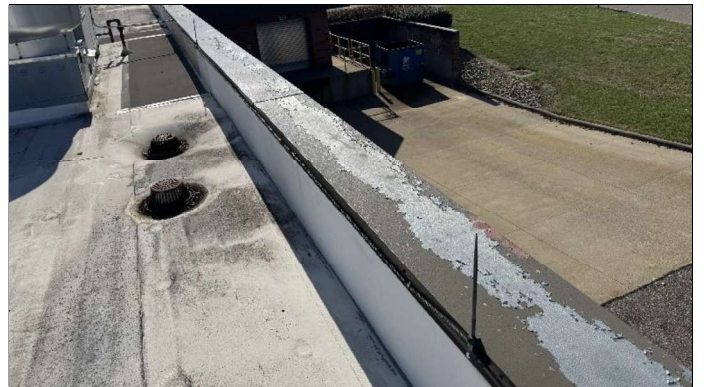
Deteriorated finish on metal coping

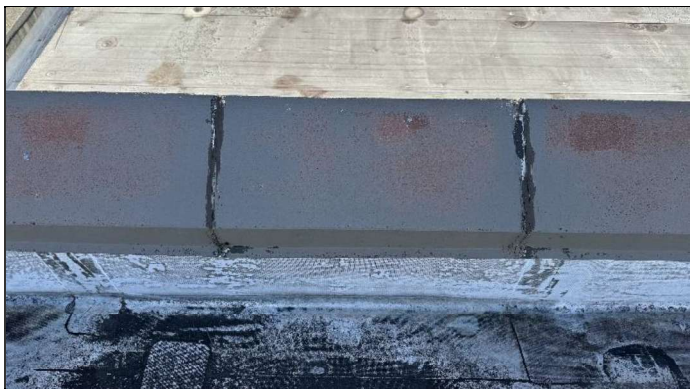
Deterioration of metal coping joints

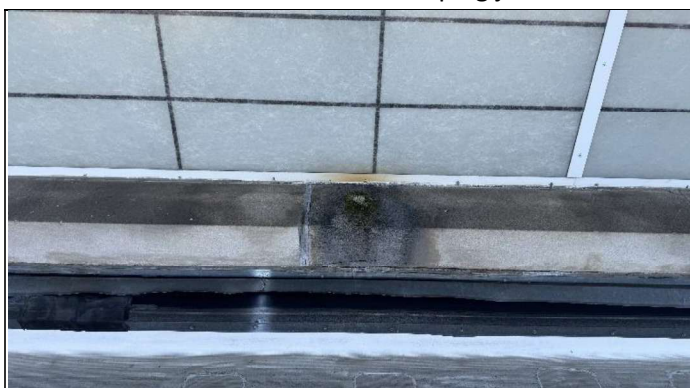
Deterioration of limestone coping above dining area

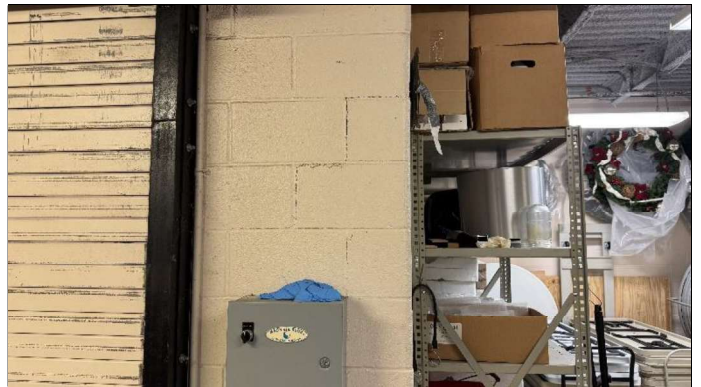
Stair step cracks were observed in the CMU load bearing wall at the east corner of the open storage area at the east end of the service corridor. It appeared that some movement of the wall may have occurred at this location. The apparent movement may be a result of runoff from the roof infiltrating the soil around the foundation in this area and causing settlement.

Cracking in CMU wall

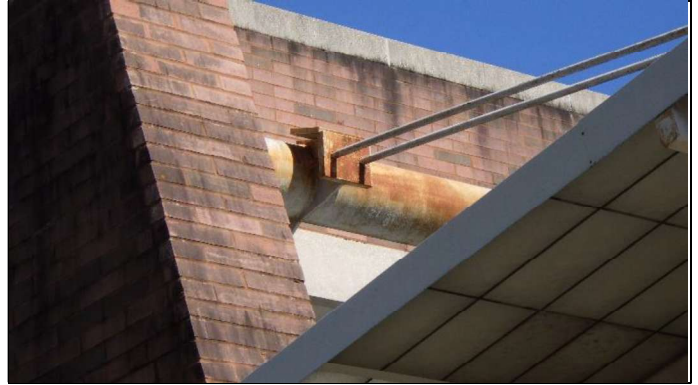
The building includes cantilevered porte-cocheres above the main front entrance and north entrance and are constructed of steel framing supported by brick masonry wing walls. The awning of the porte-cocheres consists of metal-framed, transparent panels. The steel framing exhibited surface corrosion. The wing walls exhibited stains along the surface of the brick, typically where the steel framing bears and embeds into the brick and below.

Typical stains on steel framing

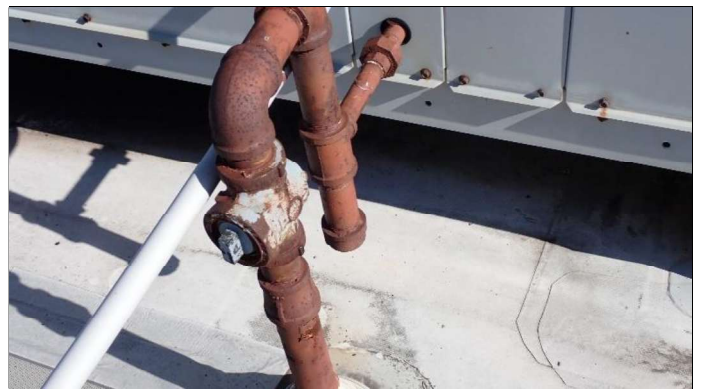
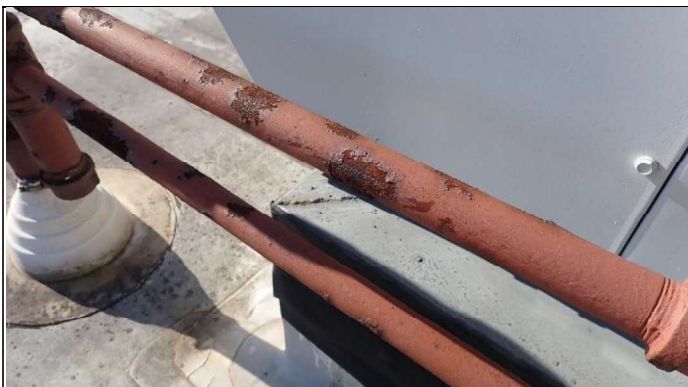
The local utility company provides natural gas to the building. This service is monitored by a single meter located on the south side of the building. This service is distributed through steel pipes. Surface corrosion was identified along the distribution pipe on the roof surface.

Surface corrosion on natural gas distribution pipes

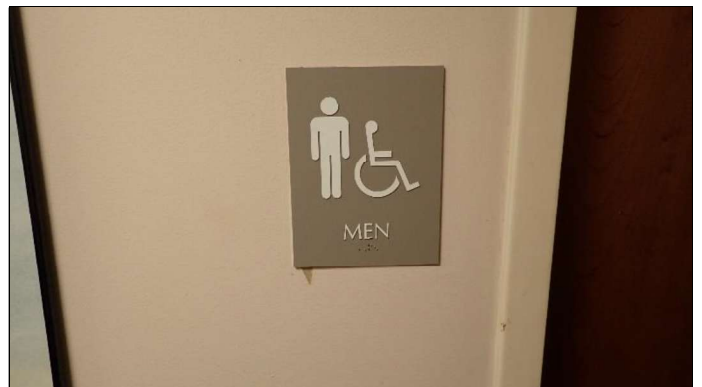
Service corridor washroom sign

Replace the accessible washroom signs in the service corridor with signage that does not indicate these washrooms are ADA accessible. Estimated cost to install these components is approximately \$500.
