# KENT STATE UNIVERSITY

## CAPITAL NEEDS ASSESSMENT REPORT

October 30, 2025

**Re: Capital Needs Assessment of Kent State Stark Conference Center**

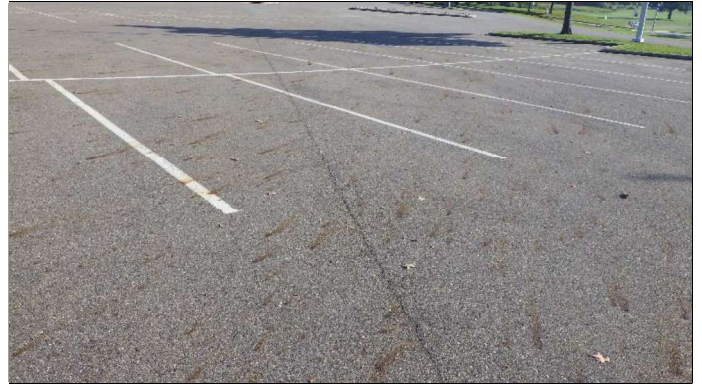
Asphalt pavement crack

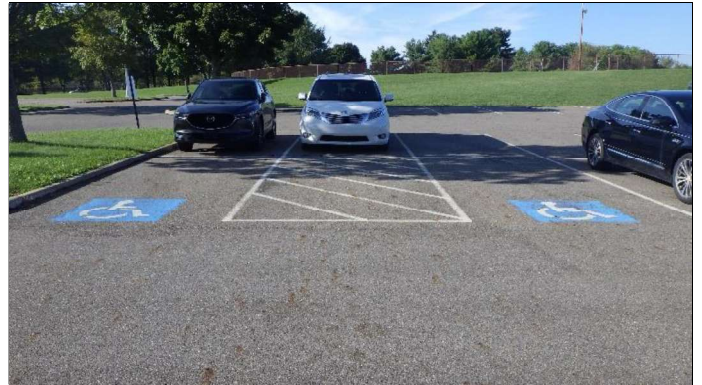
Overview of accessible parking with no signage

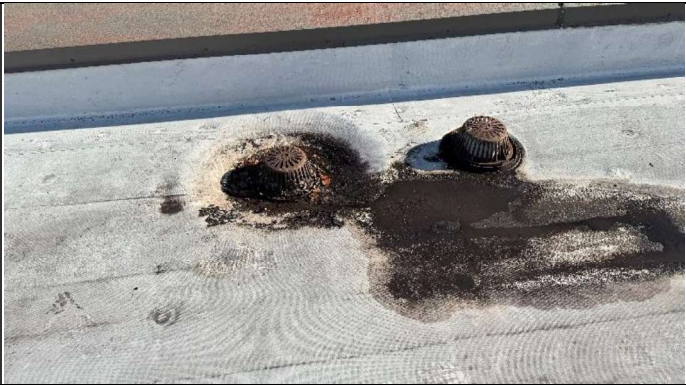
Internal roof drain

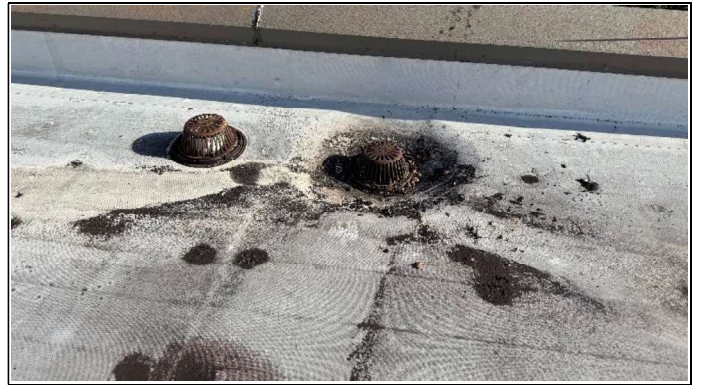
Internal roof drain

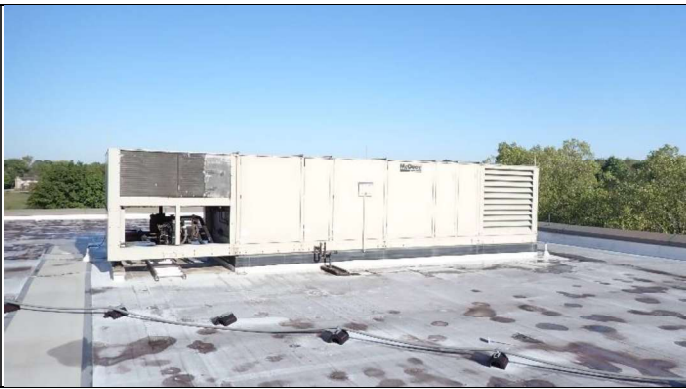
Overview of terminal unit

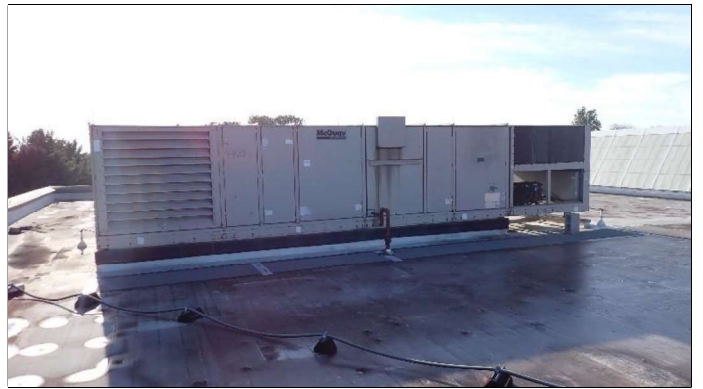
Overview of RTU

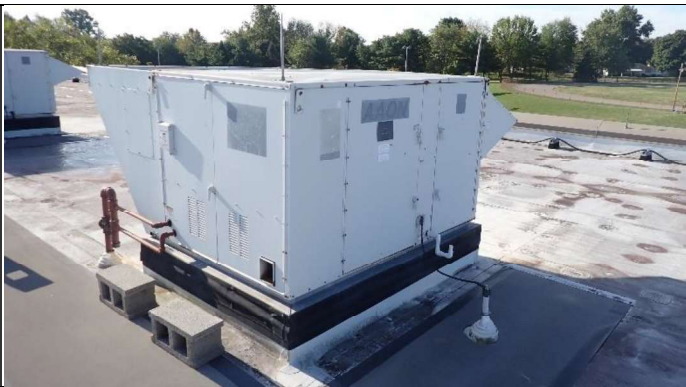
Overview of RTU

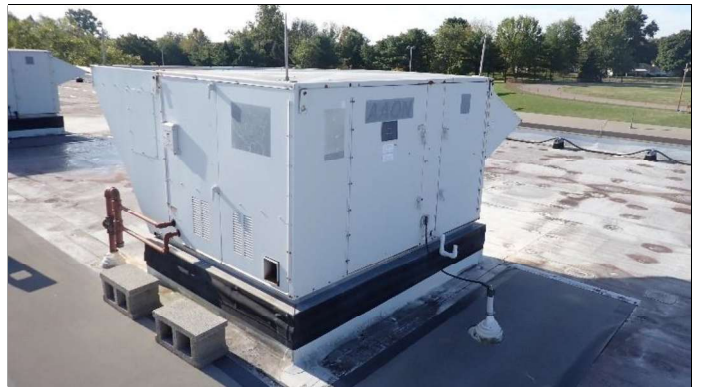
Overview of RTU

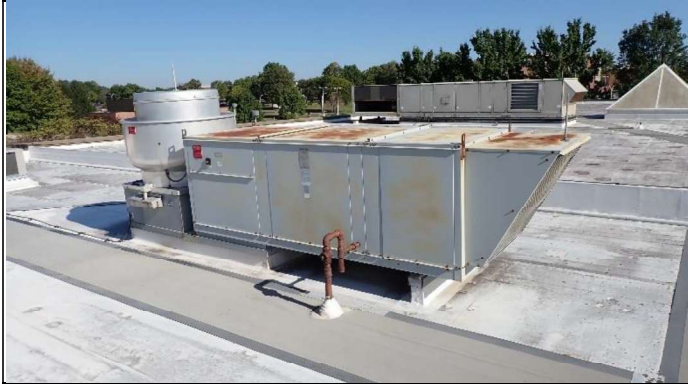
Overview of RTU

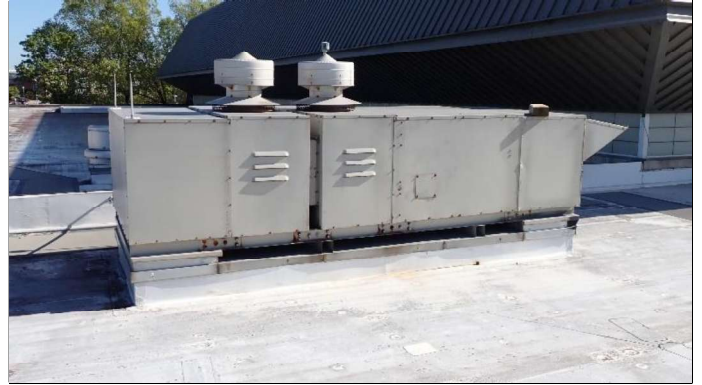
Industrial heater with make-up air

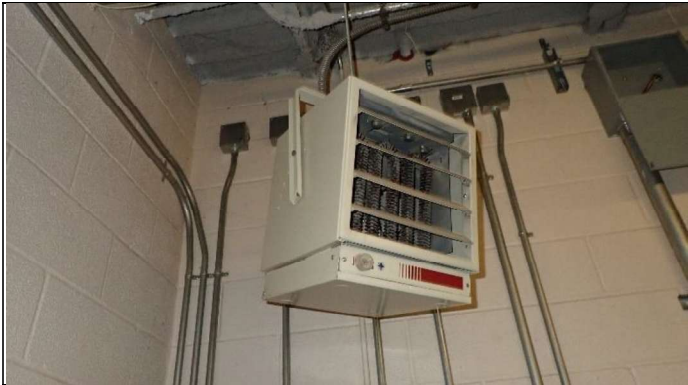
Industrial heater with make-up air

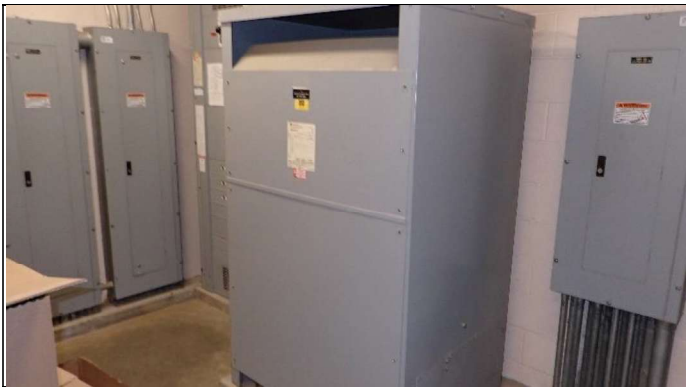
Electrical distribution equipment

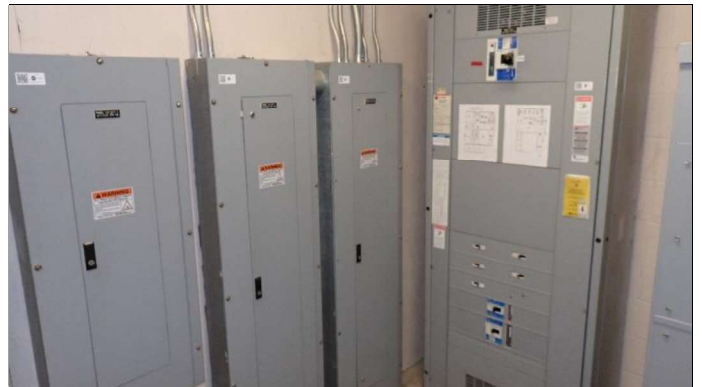
Electrical distribution equipment

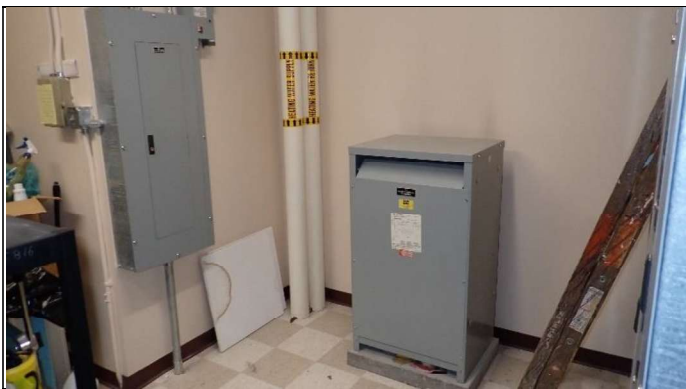
Electrical distribution equipment

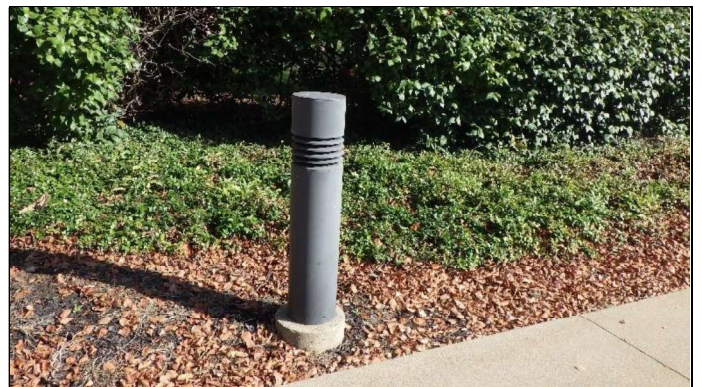
Overview of exterior light fixture

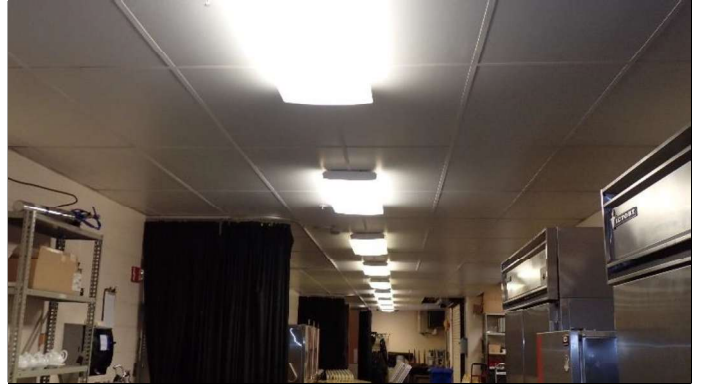
Overview of interior light fixtures

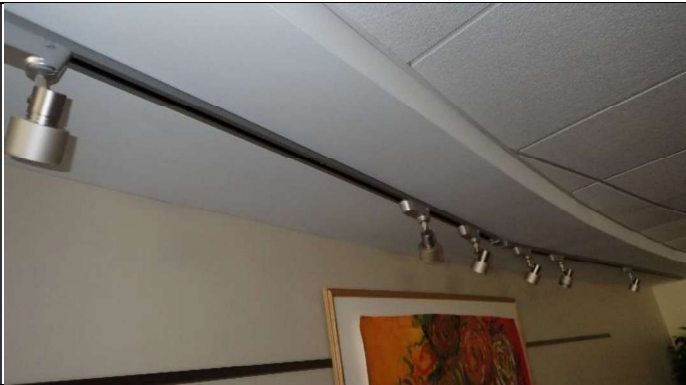
Overview of interior light fixtures

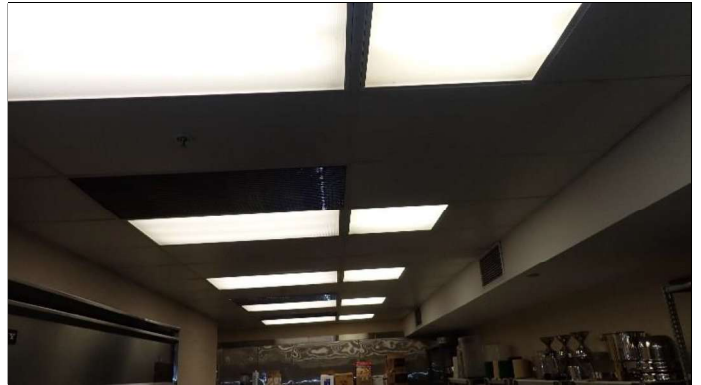
Overview of interior light fixtures

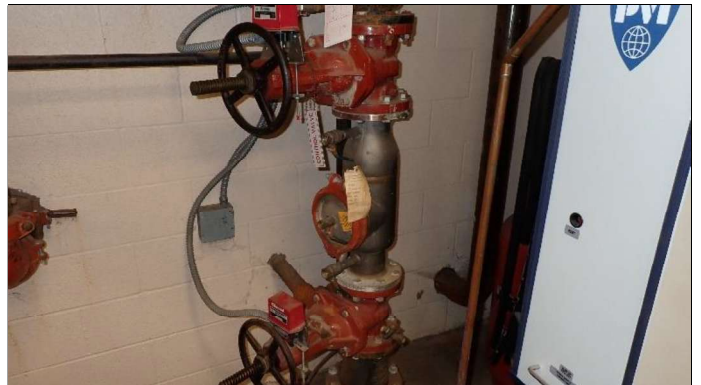
Fire sprinkler riser

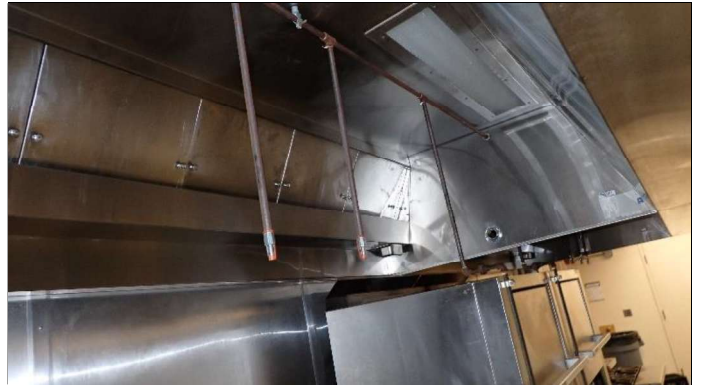
Ansul wet agent suppression system

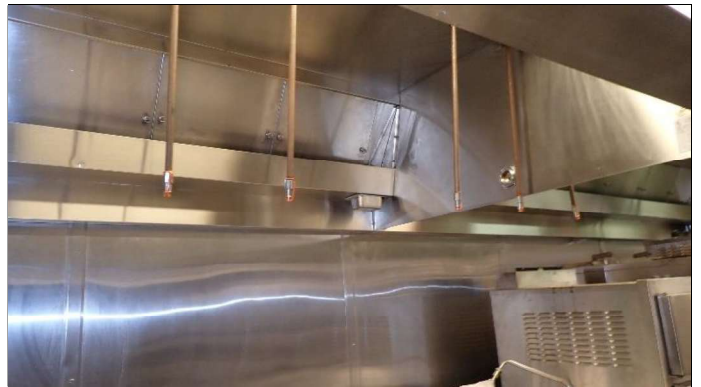
Ansul wet agent suppression system

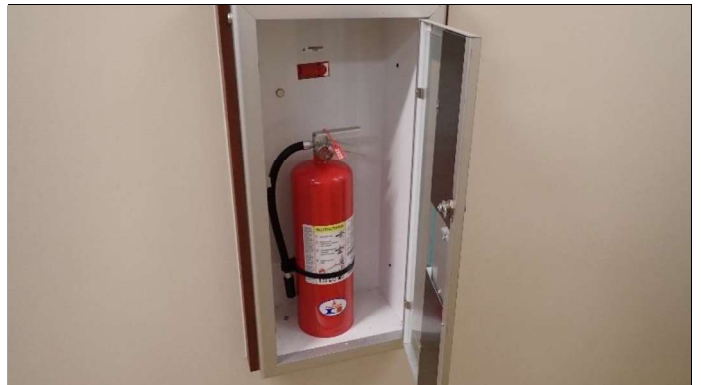
Dry chemical fire extinguisher

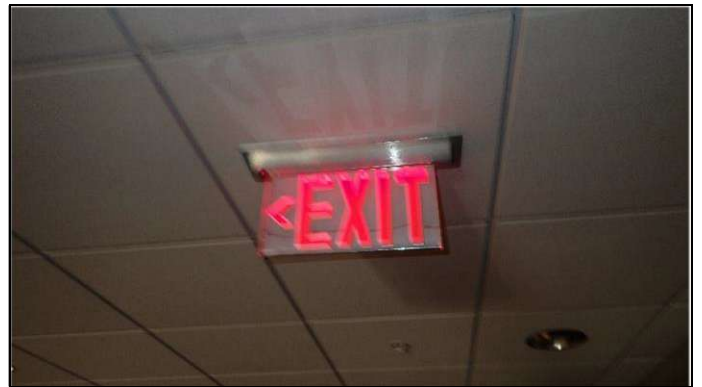
Illuminated exit sign
