# KENT STATE UNIVERSITY

## CAPITAL NEEDS ASSESSMENT REPORT

October 30, 2025

**Re: Capital Needs Assessment of Kent State Stark Conference Center**

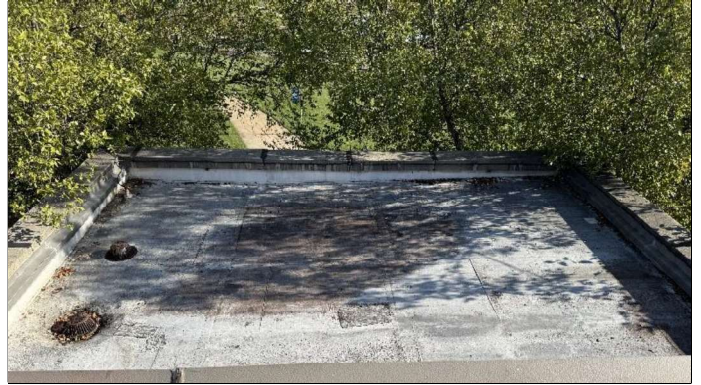
Overview of trees at north entrance roof

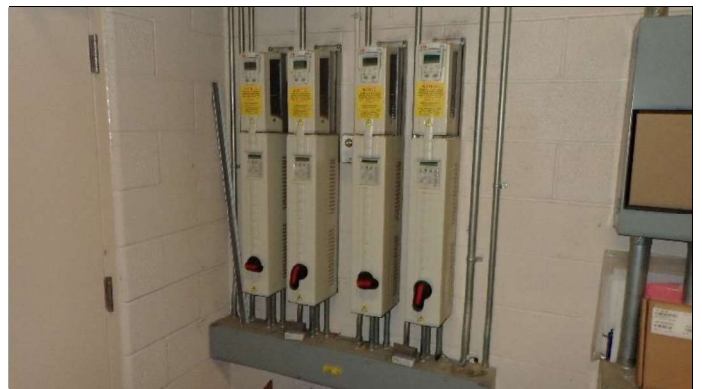
Electrical distribution equipment

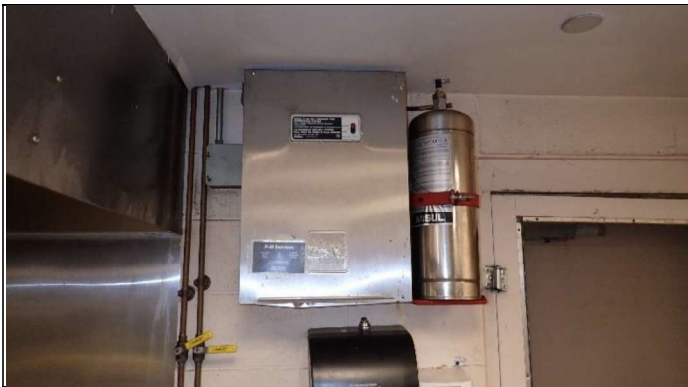
Cooking range suppression nozzles

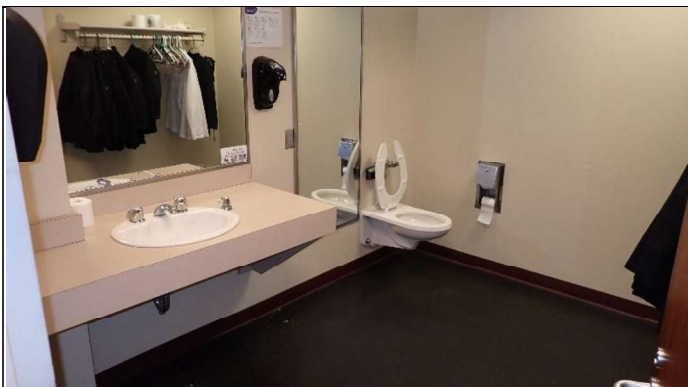
Overview of washroom in service corridor
